# FACILITY COMPLIANCE INSPECTION REPORT

## Division of Waste Management Solid Waste Section

Chatham County Closed MSW Landfill  
720 County Landfill Road  
Pittsboro, NC 27312

Post Closure Inspection (inspection of ongoing management activities and TDDSS at closed landfill site)

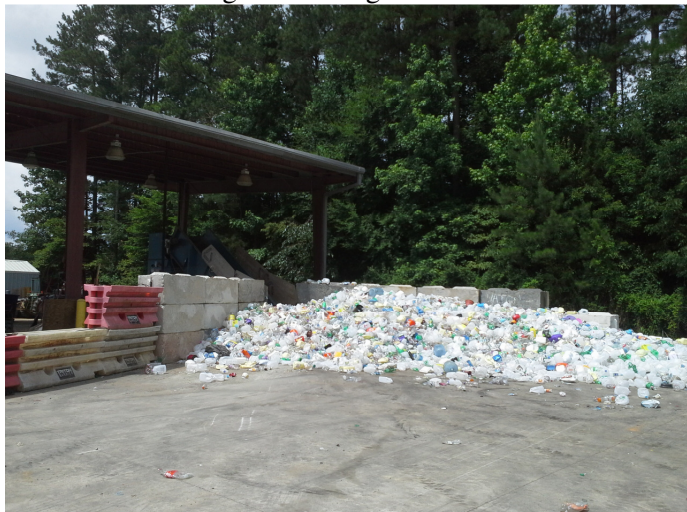
4. Plastic bottles are off-loaded onto a concrete pad and baled. Plastic bales are hauled to Waste Management Recycle America.
5. Glass bottles are stored by color in large cement block bays until hauled to Strategic Materials, Inc. (SMI).

Plastic bottle storage and baling area

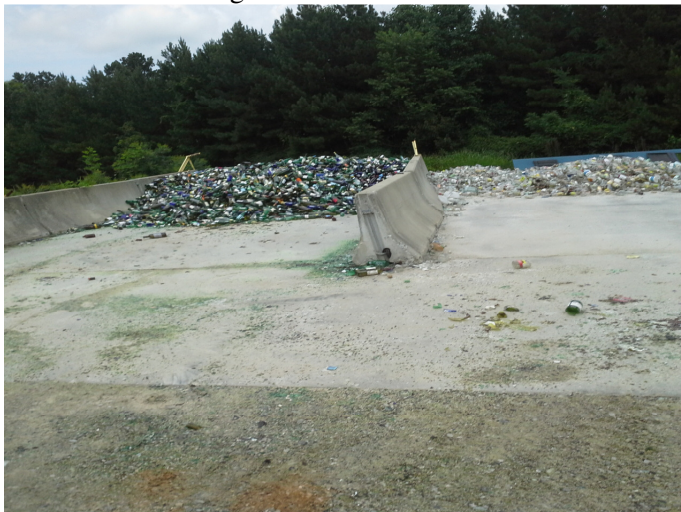
Glass bottle storage area

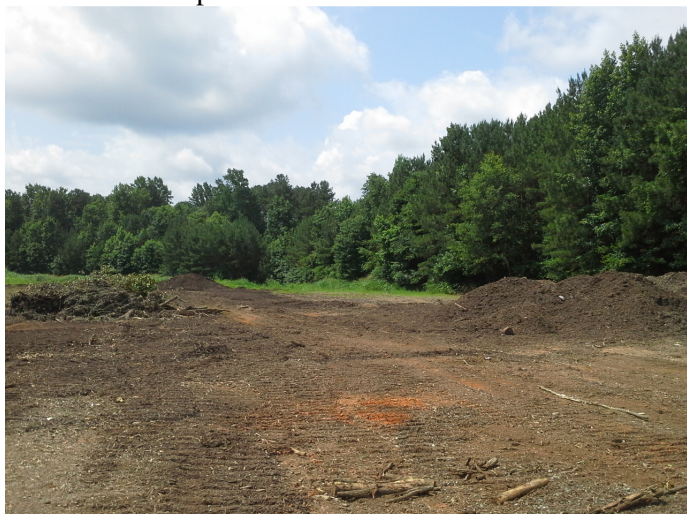
11. There were two piles of mulch on site (totaling ~ 80 yd<sup>3</sup>).

Yard waste compost area – mulch

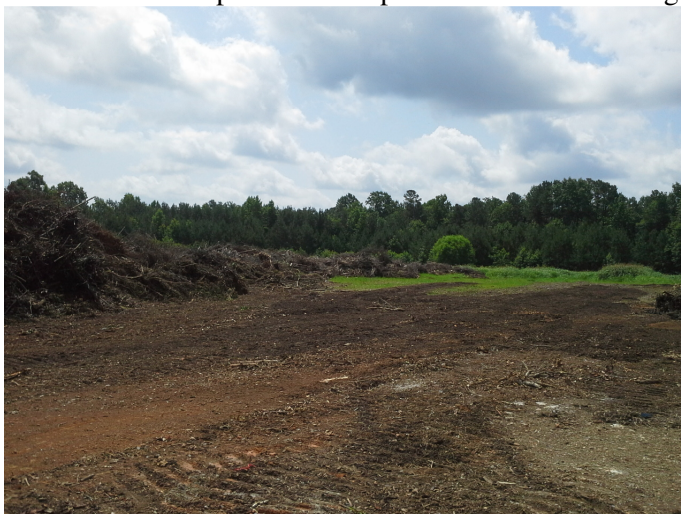
9. Unprocessed material is stored in windrows. Commonly, the facility has two windrows of unprocessed material to be ground by late winter.
10. Records indicate that there is 464 tons of unprocessed material on site (received since 02/19/13).

Yard waste compost area – unprocessed material storage

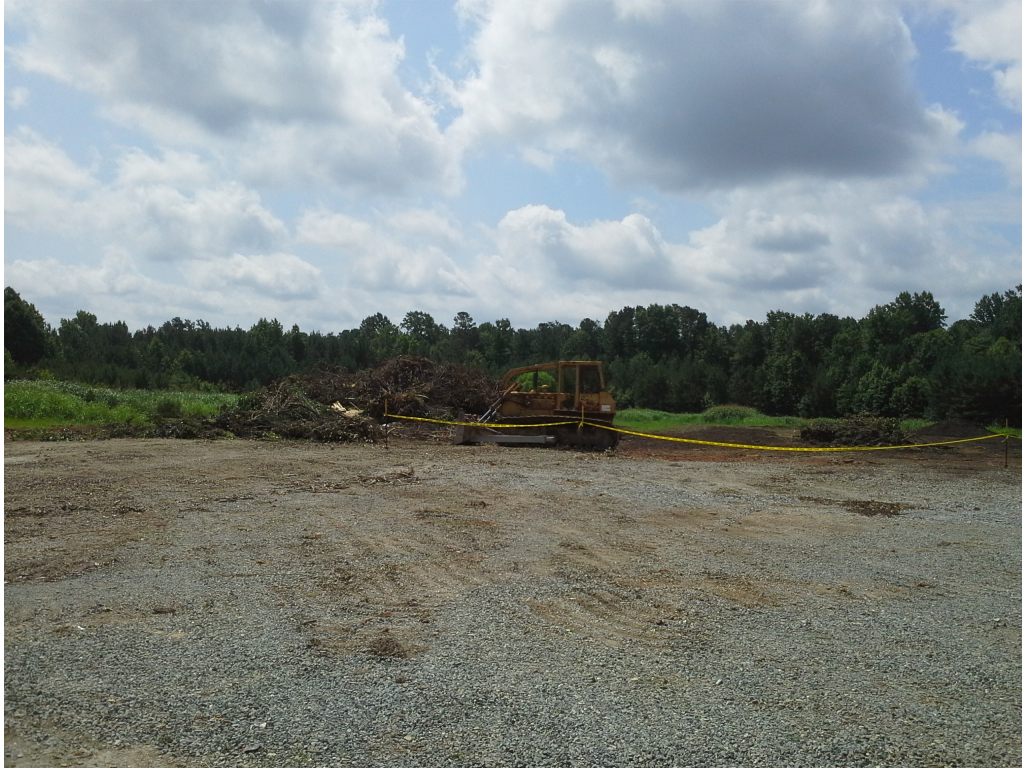
1. Chatham County has a Temporary Disaster Debris Staging Site (TDDSS, DS19-004) located adjacent to the Chatham County Solid Waste & Recycling Division office and yard waste compost operation. The site is ~ 6 acres however only ~ 2 acres is cleared of trees/ready for immediate use. It is suggested that if the entire site is expected to be ready for immediate use during a disaster, the remaining ~ 4 acres should be prepared.

2. The yard waste compost operation is considered a TDDSS (DS19-003) located adjacent to the Chatham County Solid Waste & Recycling Division office and TDDSS, DS19-004. The site is ~ 2 acres of which appeared ready for immediate use. The yard waste compost operation should be operated/maintained accordingly for possible use as storage for disaster debris.

Partial views of DS19-004 (grassy area in background) and DS19-003 (foreground)

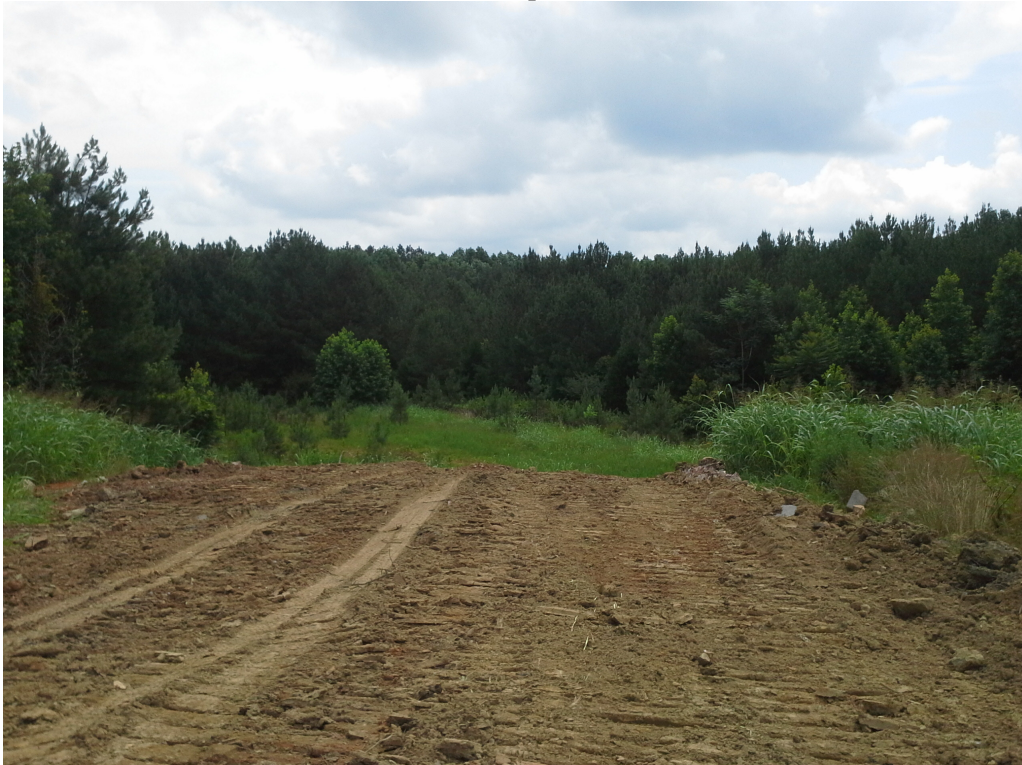
3. The notified land clearing and inert debris (LCID) landfill (N0069) is considered a TDDSS (DS19-002) located adjacent to the entrance to the closed landfill (19-01) on the property associated with the Chatham County Solid Waste & Recycling Division office. The site is ~ 1 acre. Mr. LaMontagne stated that only inert debris is placed in the LCID landfill. It is suggested that material be added/or the site graded such that it can effectively operate as a TDDSS. It appears that the rear of the landfill, purportedly not containing fill material, may pool water. Additionally it is suggested that an all-weather road be constructed and maintained to access the rear of the landfill area for ingress and egress during possible inclement weather associated with a disaster event. And develop a standard operating procedure (SOP) for utilizing the LCID landfill cap/designated landfill area as a TDDSS such that it is operated/maintained accordingly for immediate use.

DS19-002 at LCID N0069 (view atop covered material to unused area)
